IRF Global Road Conference
November 7-9, 2018 – Las Vegas, NV USA

Bridge Deck Scanning by Infrared Thermography

Masato Matsumoto, P.E.¹

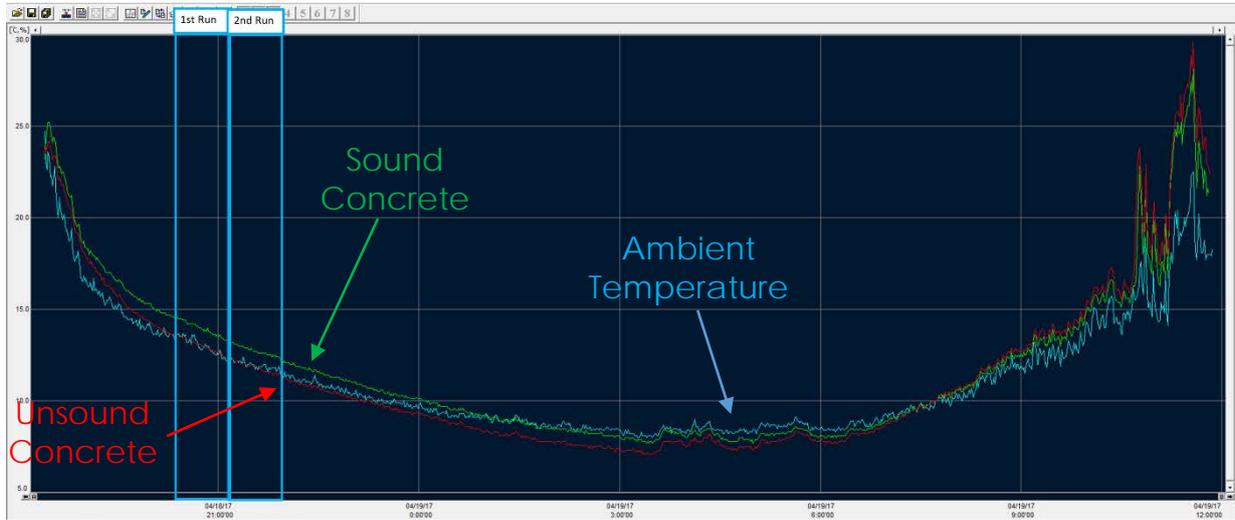
A temperature record taken near the site is displayed in Figure 10. The temperature of ambient air (light blue) and a sample test piece concrete (red and green for unsound and sound concrete, respectively) was recorded at a parking

lot near the inspection site. During the time of the IR scan (8 pm – 10 pm), approximately one-degree Celsius gap between sound and unsound concrete occurred.

Figure 10: Temperature graph recorded on April 18 and April 19. IR scanning period is shown in blue box.

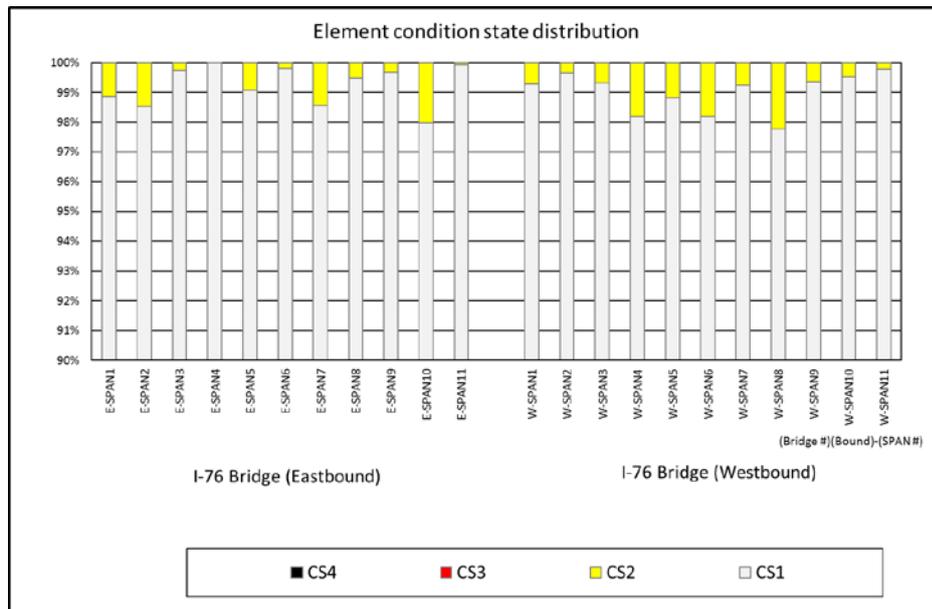
Favorable weather conditions and a smooth scan resulted in a successful analysis of the bridge. All data collected—raw infrared, processed infrared, and visual—were compared closely side-by-side to eliminate false positives. The AASHTO Manual for Bridge Element Inspection, First Edition (AASHTO, 2013) provides a guideline for condition state definition of bridge elements based on the severity of delamination, spalling, exposed rebar, and cracking conditions. For the East bound bridge, the element condition state (CS) for reinforced concrete decks (Element #12) was determined based on the mobile scanning results. Broadly, this bridge exhibited only slight signs of defects compared to the overall bridge roadway deck area - less than 2% of deck area with some delamination. The distribution and location of the AASHTO-categorized deficiencies for each bridge was also prepared in the form of a map, where the deficiencies were highlighted and super-imposed onto an image of the bridge decks. Percentage of deck areas for each condition state was also summarized for each span of the bridge and graphically displayed as shown in Figure 11. This information can be used by bridge owners as a general assessment, and can help to prioritize future repair/rehabilitation programs by identifying deficient areas in their early stages.

Figure 11. Condition state distribution for each span of the bridge

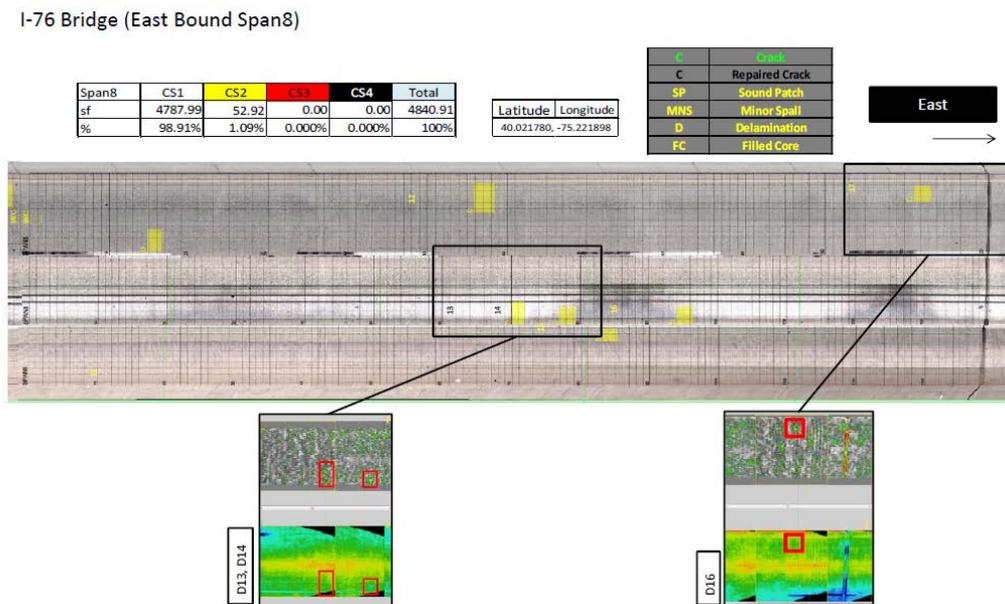
The result from the high-speed scanning was displayed on the deficiency map for details (see Figures 12 and 13 for examples). The tables in the deficiency map show the percentage of deck areas for each condition state. Two weeks later, the right lane and the shoulder of the East bound bridge were closed for visual inspection and sounding tests for validation purposes (Figure 14). Figure 15 is the validation results depicted on the deficiency map for the East bound bridge. The areas marked in orange color are detected as delamination by the sounding test. The areas in yellow color are detected as potentially delaminated by the high-speed infrared scan. We added GREEN dashed boxes if these orange and yellow areas were consistent (that means correct detection by infrared). However, some of the yellow areas were proved to be "false positive", and we added RED dashed boxes to these false positives. Generally speaking, the defective areas were successfully detected by the infrared with only two exceptions in Span 2 and Span 10. In these areas, a signature of delamination was found by the IR scan, but we interpreted these areas as false positive on the basis that exposed aggregate and a continuous discoloration on the middle of the deck surface camouflaged this area and it was challenging to distinguish this area from the other sound areas which showed a similar temperature distribution. Most of the false positives were also caused by the same reason.

Figure 13: Deficiency map for Span 8 of the East bound bridge

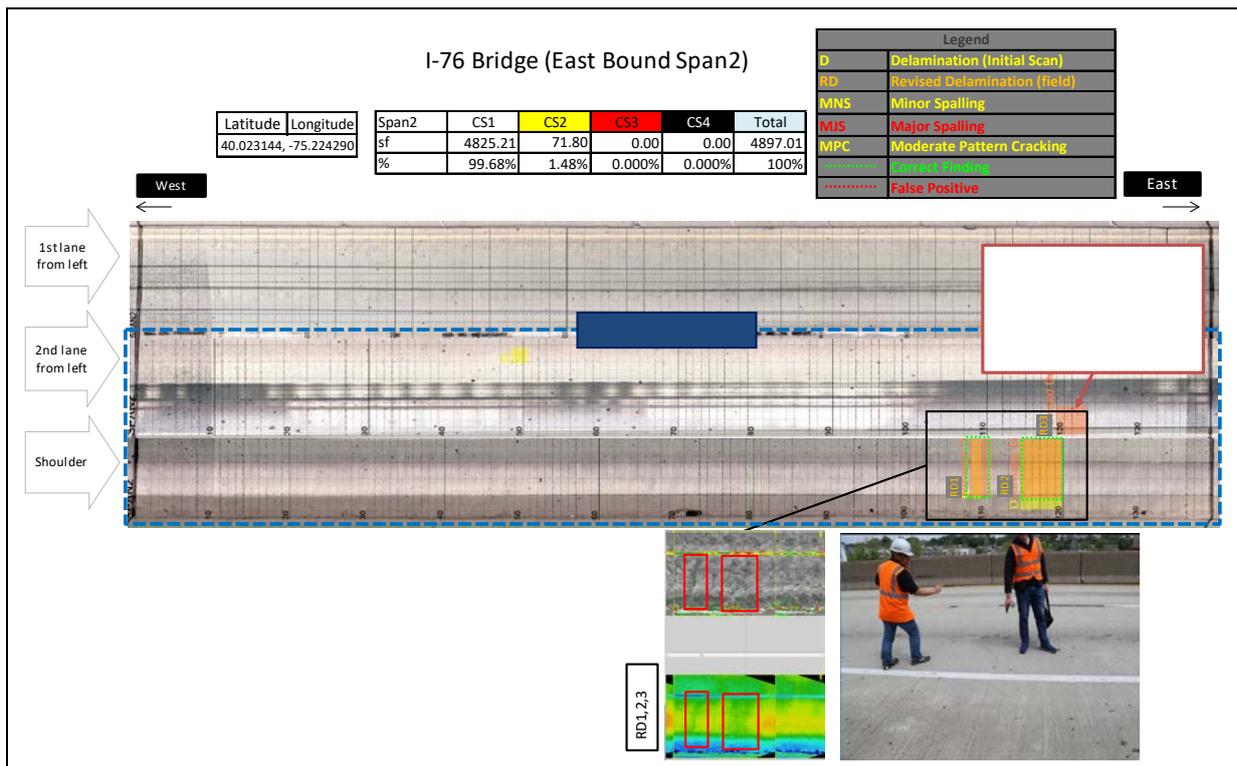
Figure 15: Deficiency map with validation results (Span 2, East bound)

The result from the high-speed scanning for the concrete deck for the Pencoyd Viaduct was displayed on the deficiency maps, and will be further examined as the analysis of the viaduct continues in the coming year. The results were validated by the sounding test applied during lane closure, and provided an excellent opportunity to cross check our results, and heighten our knowledge of signatures of delamination. The sounding test proved that most of the defective areas were successfully detected by the infrared thermography technology. However, the exposed aggregate

due to the abrasion of concrete made it challenging to distinguish the delaminated and sound area from the infrared results, causing some false detections. From the validation results, it can be concluded that high-speed infrared and digital image scanning can provide valuable information of current deck conditions with reasonable accuracy. The information provided for identification and mapping of deficiencies will serve as an invaluable reference for the purposes of future evaluation and comparison. The bridge owner can use the comprehensive deficiency map for monitoring distressed deck areas and planning future repairs, as well as summarizing AASHTO element level inspections in square footage or percentage of deck area. The deficiency map and element condition summary generated by the deck scanning technology can serve as a solution for more efficient, objective, and safer bridge inspections in comparison to traditional approaches, especially for relatively large-scale bridges with heavy traffic volume. To assure the reliability of IR data, it is recommended to select the best field data collection time periods and to use an IR camera equipped with a cooled detector. Using enhanced analytical tools, the engineer can pinpoint locations of deficiency, allowing more efficient inspection protocols, improved operational safety, all while driving lower life cycle costs for owners. Other non-destructive evaluation technologies and any hand-held scans can also be applied for more detailed condition assessment for the selected areas denoted by high-speed scanning technology. Combining the deferent type of NDTs depending on their data collection speed, accuracy and cost will provide better solutions for bridge owners to efficiently and properly monitor the bridge conditions, supporting data-driven (objective) decision making on bridge maintenance and management.
