December, 2014

Comparison of Infrared Cameras for Concrete Bridge Deck Scanning: - Vol.2 Field Test at Haymarket Bridge -

NEXCO-West USA, Inc.

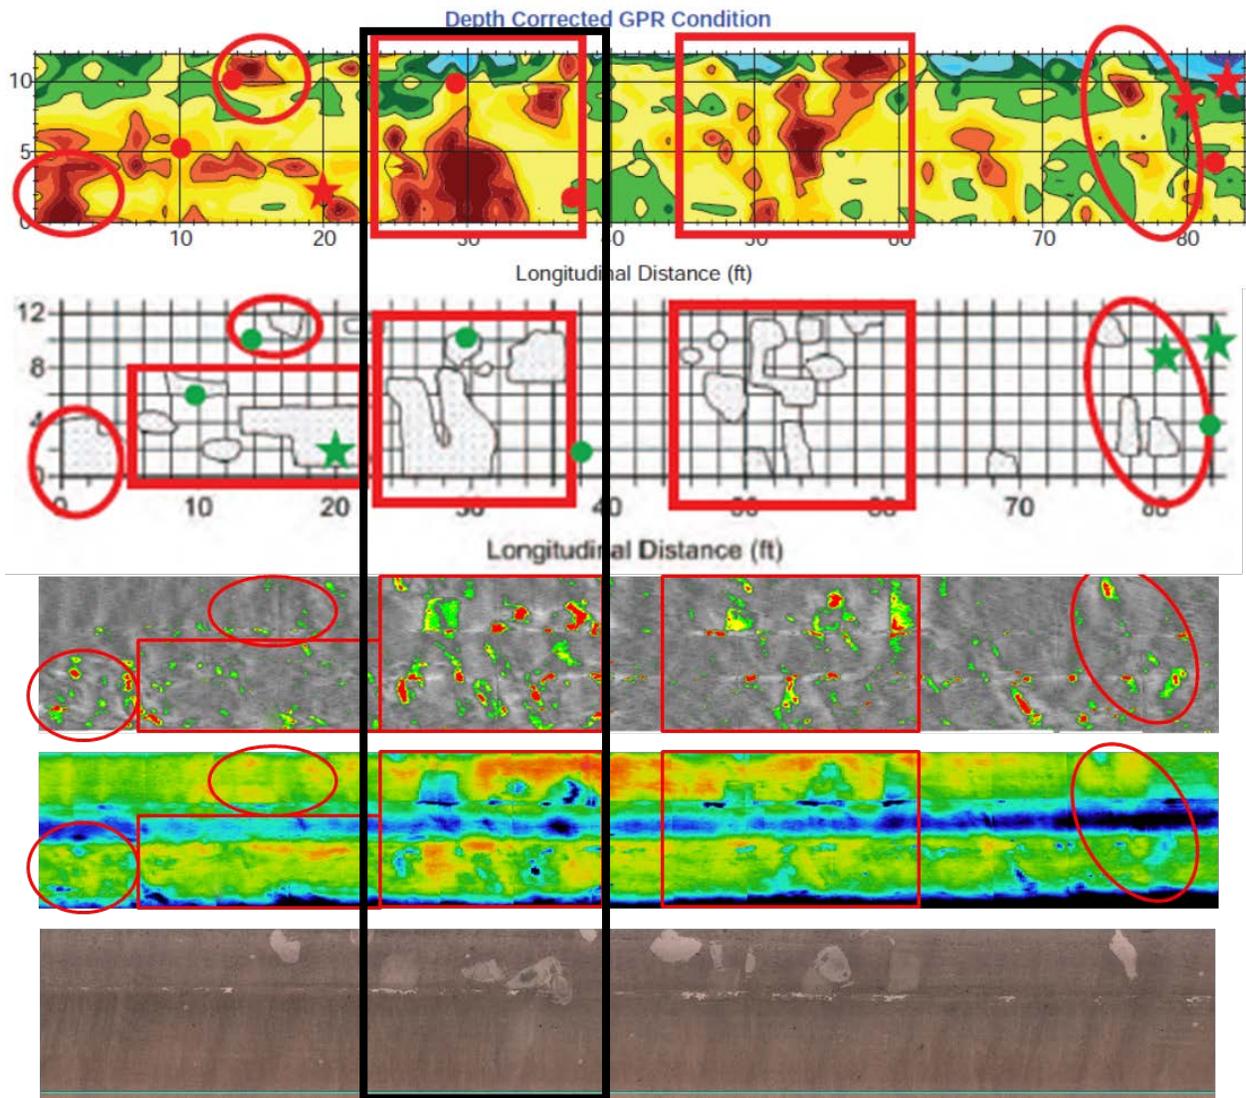
Figure 7: SHRP2 GPR, hammer sounding/chain dragging, and infrared results comparison (infrared data collected by the SC5600 camera)

Firstly, photography with the SC5600 was carried out and compared with SHRP2's GPR results (Figure 7). Though the shapes of the two analyses do not match exactly, the areas in which delaminations were detected are mostly the same. In other words, the outcome obtained by infrared scanning is comparable to conventional methods, and can specifically identify areas of concern in bridge decks to an unprecedented degree.

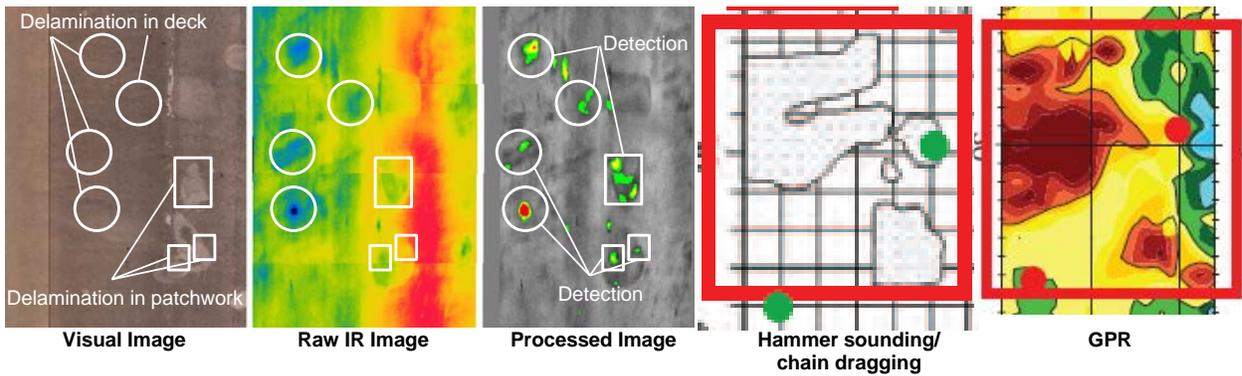
Figure 14: SC5600 results when temperature differential is 0.2°C (20:50)

In Figures 14-16, a sample of the results for the SC5600, T640, and T420 are shown respectively. The SHRP2 findings are also shown on the side for a clear, direct comparison. Detected delaminations on the deck are circled in white, delaminations within patched areas are highlighted by a white rectangle, and false detections are highlighted by a yellow rectangle. The dotted shapes represent a failure in detection. Since the SC5600's results turned out to be the most reliable, it was used as a benchmark for comparison. With the SC5600, the difference between delaminations within patched areas and other slab delaminations

can be recognized, but due to their insufficient exposure times, this difference cannot be reliably discerned with the T640 and T420. With blurred images, post analysis becomes difficult. While the T640 was able to detect one delamination within a patched area and one in the upper portion of the deck, it missed five other instances detected by the SC5600. Only one instance (the upper patched area delamination) was correctly detected by the T420. False detections occurred in both the T series' results. See Table 2 for a description of individual results.

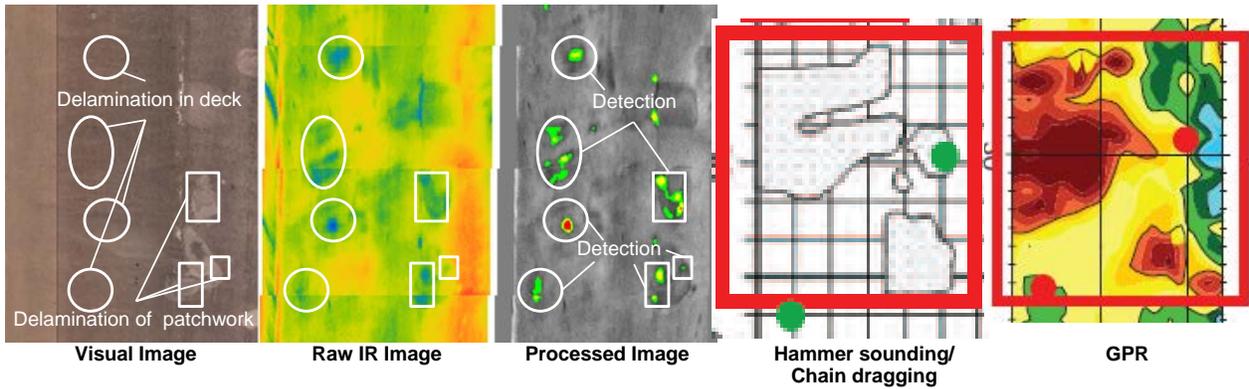
Figure 18: SC5600 results when temperature differential is 0.1°C (22:30)

Although the temperature differential is smaller and provides more challenging, condition for delamination detection, the SC5600 successfully found the delaminated areas with little change. Given the longer exposure time and a lack of environmental settings, the images for the T series changed drastically compared to the earlier time period. Most notably, many false detections and a general lack of definition were observed. For both T series cameras, the second delaminated patch and all of the four previous deck delaminations went unseen. See Table 3 for a description of individual results.
